PHASE I REPORT
NATIONAL DAM INSPECTION PROGRAM

Name of Dam: SCS DAM PA-451
State & State No.: PENNSYLVANIA, 64-197
County: WAYNE
Stream: NEVIN CREEK
Date of Inspection: November 6, 1979

SCS DAM PA-451

NDI-ID NO. PA-01031

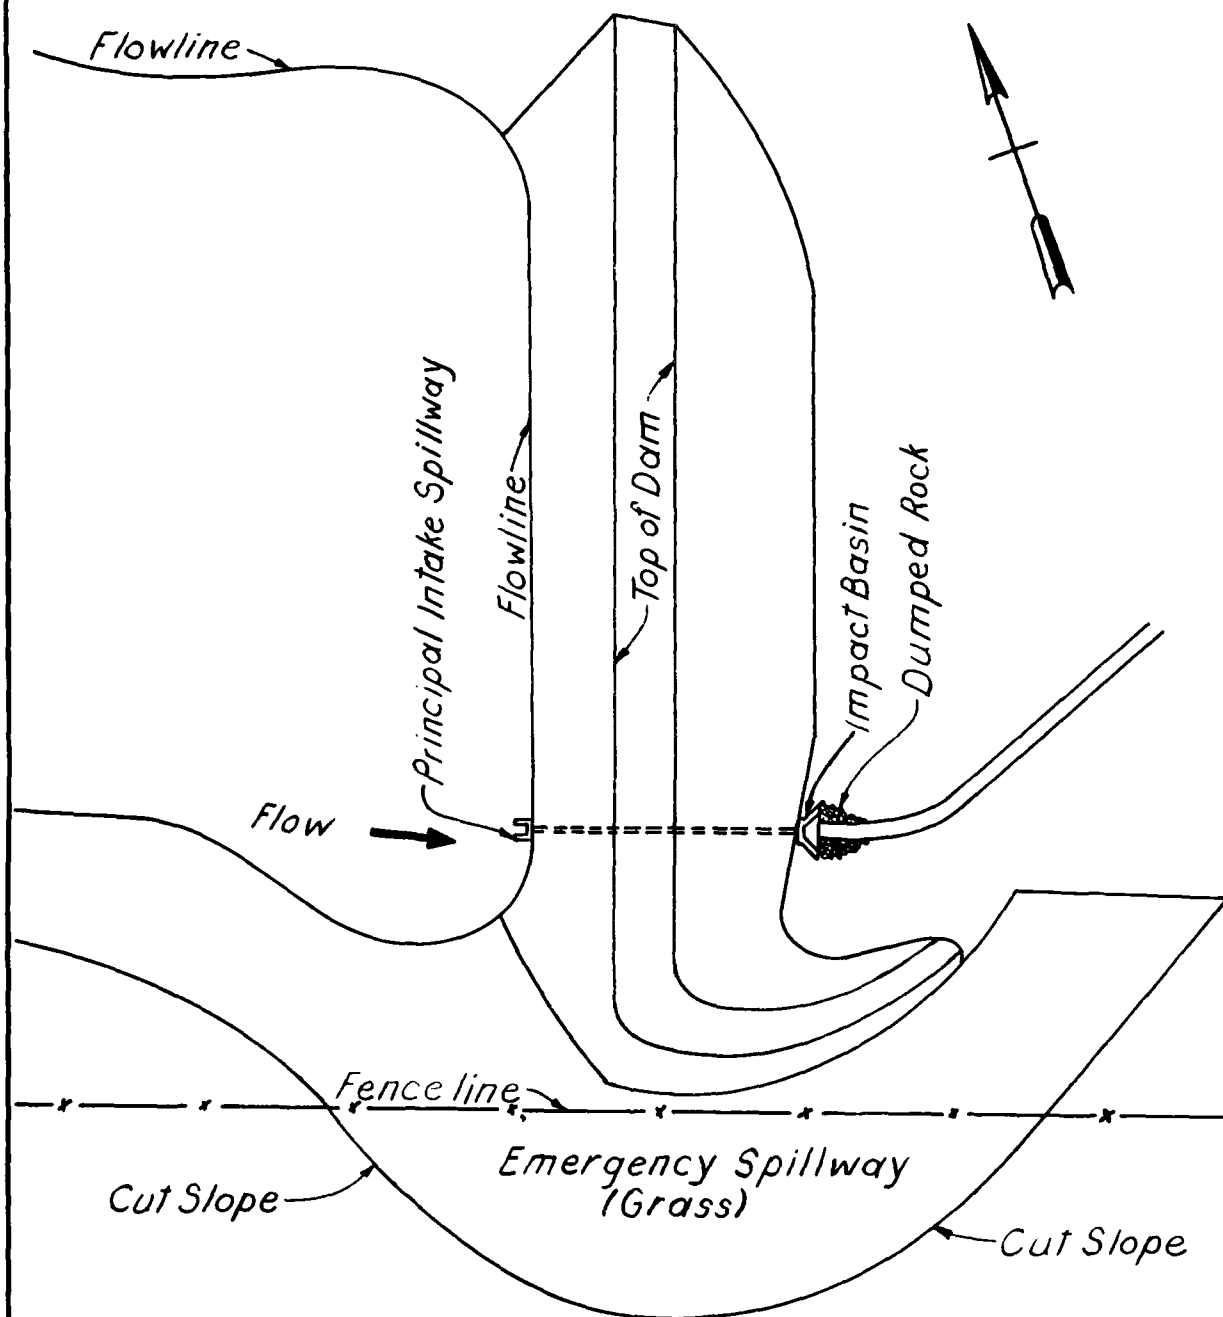
PLATE A-I

The emergency spillway in the right abutment appeared to be in good condition with a good grass mat for erosion protection. The side slopes are stable and the flow of water is directed away from the toe of dam with a spur dike constructed from soil (Appendix A, Plate A-I). The principal spillway was in good condition.

E. RIPRAP FAILURES	No riprap on exposed upstream slope. Appears stone protection below flow line.
F. JUNCTION EMBANKMENT & ABUTMENT OR SPILLWAY	Left abutment is good. Right end of embankment curves and forms left side of emergency. (Plate A-I).

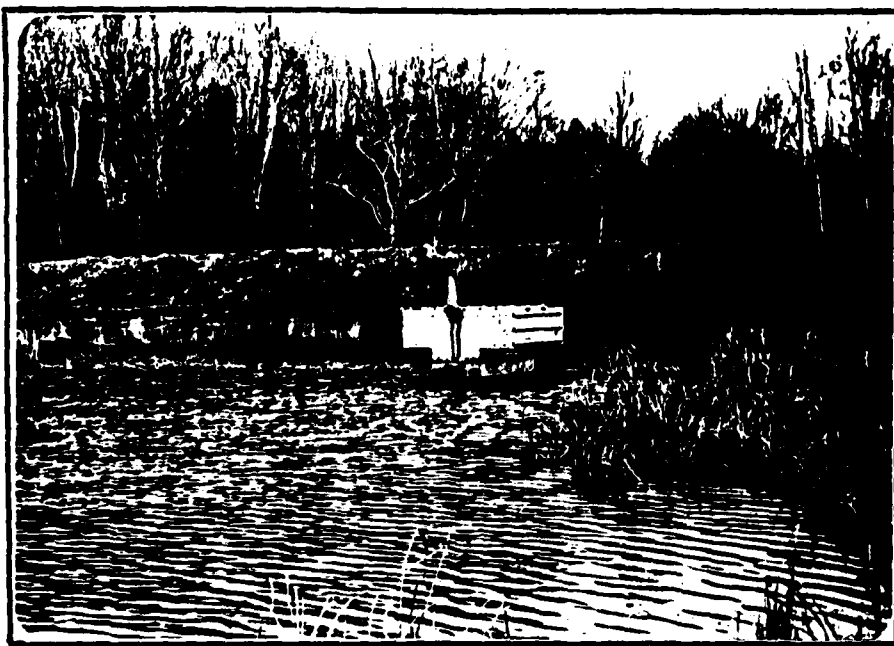
UPSTREAM SLOPE & INLET STRUCTURE - NO. 4
